# Seismic simulation of 1/4 scale unreinforced masonry models retrofitted with PP-band meshes

Paola MAYORCA, Regular Member, Institute of Industrial Science, University of Tokyo  
 Navaratnarajah SATHIPARAN, Student Member, Institute of Industrial Science, University of Tokyo  
 Ramesh GURAGAIN, Student Member, Institute of Industrial Science, University of Tokyo  
 Kourosh NASROLLAHZADEH NESHELI, Regular Member, Institute of Industrial Science, University of Tokyo  
 Kimiro MEGURO, Regular Member, Institute of Industrial Science, University of Tokyo

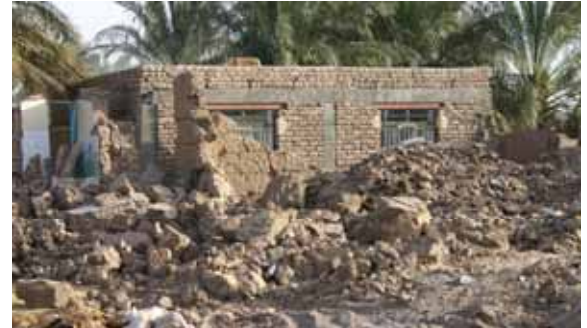
Fig. 1 Collapsed adobe house as a result of the 2003 Bam earthquake

Human casualties due to earthquakes are mostly due to structural collapse mainly that of unreinforced masonry buildings including earthen structures [1] (Figure 1). The existing world housing stock is mostly composed of this type of seismically vulnerable dwellings [2]. Retrofitting of low earthquake-resistant masonry structures is the key issue to significantly reduce casualties. In addition, it decreases the costs of rescue and first aid activities, rubble removal, temporary residence building, and permanent residence reconstruction to re-establish normal daily life [3] contributing to the sustainability of the affected countries' development.

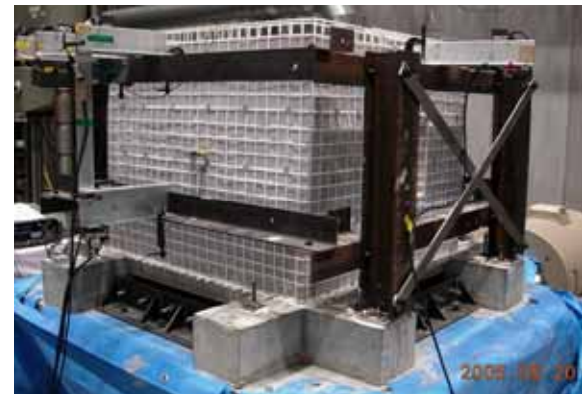
Fig. 2 Test setup

Two identical 1/4 scale models were built using bricks and cement, lime and sand (1:8:20) mortar. Both models represented a one-storey box-like building without roof (Figure 2). The model dimensions were 950(L) x 950(W) x 720(H) mm<sup>3</sup> and wall thickness was 50mm. A window (243x485mm<sup>2</sup>) and a door (325x245mm<sup>2</sup>) were provided at two opposite walls. The masonry mechanical properties, compatible with the typical materials found in developing countries, are shown below.

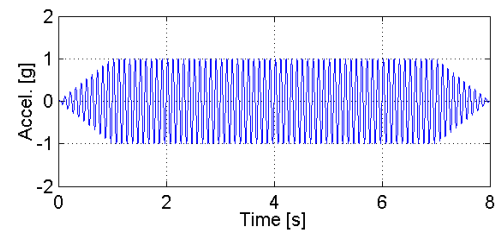
Fig. 3 Input motion waveform ( $f=10\text{Hz}$ ,  $A=1\text{g}$ )

The models were subjected to unidirectional sinusoidal excitations (parallel to the walls with openings) with amplitudes and frequencies varying from 0.05 to 1.4g, and from 35 to 5Hz, respectively. Figures 3 and 4 show the typical input waveform and

loading sequence, correspondingly. The latter also shows the JMA intensities for each input. The sinusoidal waveform was used for simplicity as the experiment results will be used for the validation of numerical models. The structural response was captured with accelerometers and laser displacement meters.

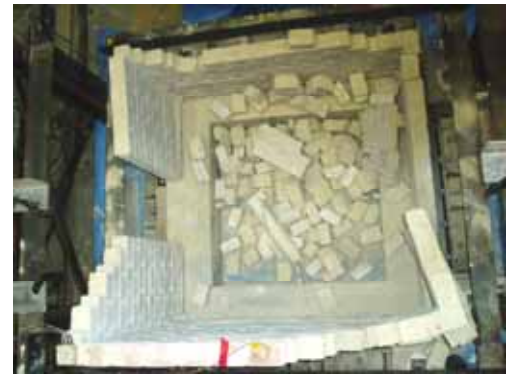
Fig. 5 Non-retrofitted model after Run 46

Both specimens were loaded following exactly the same sequence. In the elastic range and initial cracking stage, both models behave similarly, which is consistent with the results of static tests [7]. Until Run 41, walls parallel to the shaking exhibited tension cracks at the lower most mortar joint, next to the openings, and diagonal shear cracks at the opening corners. Walls perpendicular to the shake only had tension cracks along horizontal joints. After this run, the specimen NR-40 rapidly degraded, the existing cracks widened and a few new ones appeared. It completely collapsed during Run 46 (Figure 5).

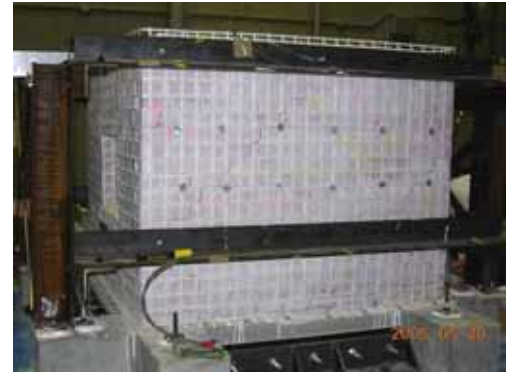
Fig. 6 Retrofitted model after Run 46

On the other hand, new cracks appeared in the model R-40 as loading progressed. After Run 46, it did not exhibit considerable residual deformations (Figure 6). Specimen R-40 was loaded 16 more times with shakes of increasing intensity, 6 of them with JMAI 6- or more. Even after these severe demands, the structure did not collapse (Figure 7). Figure 8 shows crack patterns of two model walls. R-40 experienced input velocities and deformations four and ten times larger than NR-40, respectively.

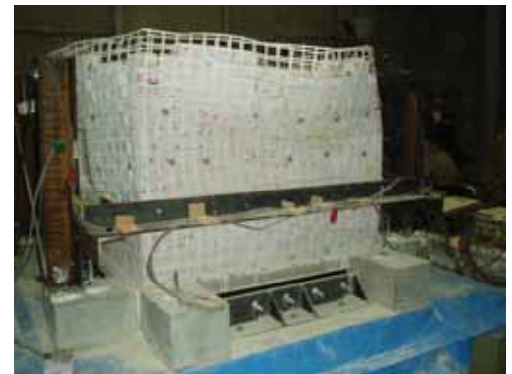
Fig. 7 Retrofitted model after Run 61

In terms of damage level, NR-40 exhibited total collapse during Run 46. On the other hand, R-40 had Life Safety performance level up to Run 61, which had a JMAI 6+. It is worth noting that before the structure cracked there were no major differences in the models' behavior. However, after cracking it was clear that the structural ductility was considerably increased. During the test, sliding along cracked mortar joints was notorious and it is considered to be one of the major mechanisms of energy dissipation of the proposed retrofitting method.

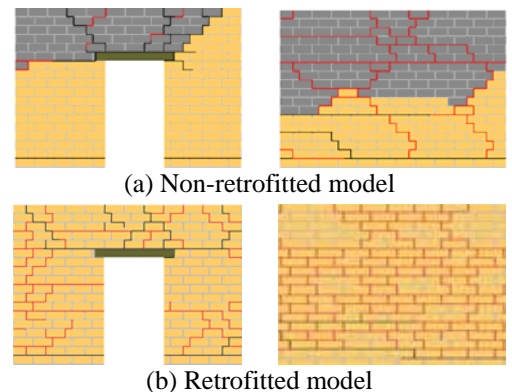
Fig. 8 East and south wall crack patterns (Cracks before Run 41: Black; Cracks after Run 41: Red)
